20 Common Mistakes Installing PV Systems

21 December 2015, v1.1

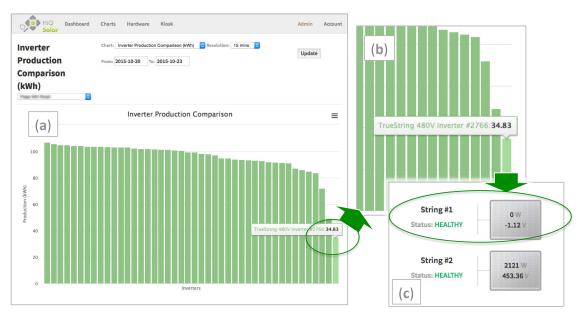
Figure 1: Identifying the lowest performing inverter in an array

This can be very difficult to detect and diagnose with large string and central inverters, but this error is very common. *Easy to see with the TrueString inverters. For example,* Figure 1 *shows a graph comparing inverter outputs for an array (a); the lowest performer (#2766) is easy to identify (b). Looking at the performance summary for that specific inverter it is obvious that one string (String 1) is the culprit (c).*

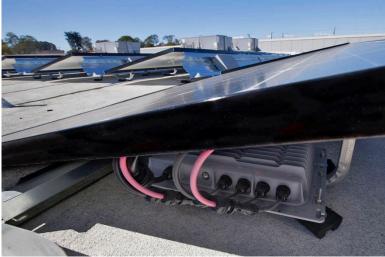
Figure 2: Clearly identified string polarities make miswiring harder

Very common where custom jumpers are used, can even have same gender connectors on each end. In addition to the string not producing power, it is possible that this can damage the inverter. Errors like this are less likely if wiring is clearly identified, such as in the installation of Figure 2 below.

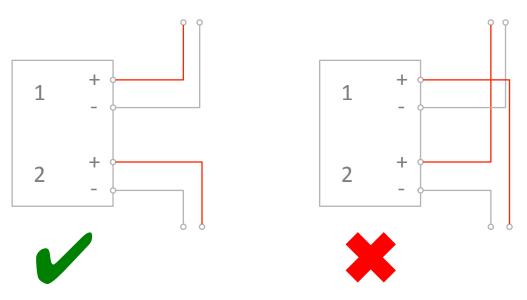
Figure 3: Connecting wires from unrelated strings

This is less common, but we have seen it – plus and minus wires of unrelated strings connected to each input. For large string inverters with many strings bundled together it can even be each side of a string connected to different inverters. As with the previous point, clear labeling at each end of wiring runs is usually worth the time.

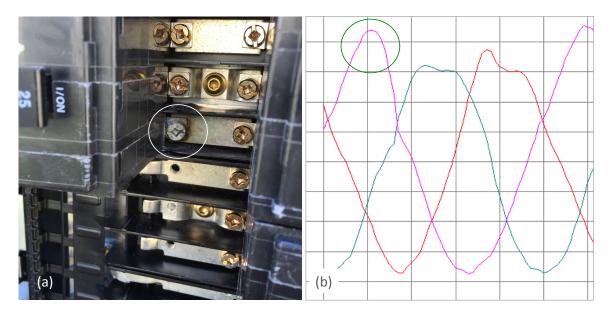
The picture shows one phase of a 3-phase breaker not torqued down properly, which resulted in a high resistance and overvoltage tripping of the inverter.

Grid voltage measures ok until power is exported from the inverter – because of the high resistance the voltage then rises, and can cause overvoltage tripping of the inverter.

In addition to the example above, breakers can fail in a lot of ways on their own, although this is more common in older systems – they can fail open or closed, or just one phase can fail open or closed when the handle indicates all three phases are closed or vice versa. Very dangerous, always de-energize and test, test again before touching – don't trust the label on the handle.
